Issue no. 3/2014:

Oil filter OX 171/2D: engine damage caused by dangerous replicas

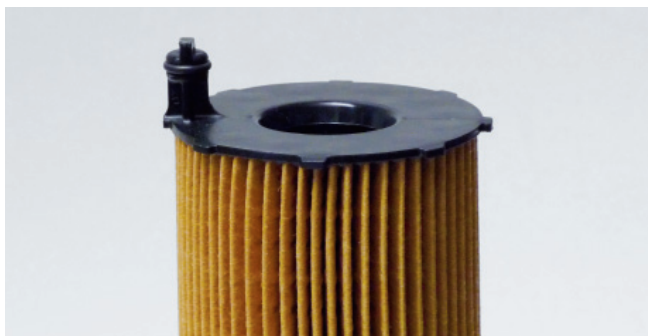
Figure 1: Well thought-out to the last detail: the patented pin for the MAHLE oil filter insert with O-ring seal.

A black plastic mandrel with an O-ring seal is mounted at the end plate of the filter element—known throughout the industry as the MAHLE pin. In the assembled state, the pin fits precisely into the bore in the filter housing and seals it off.

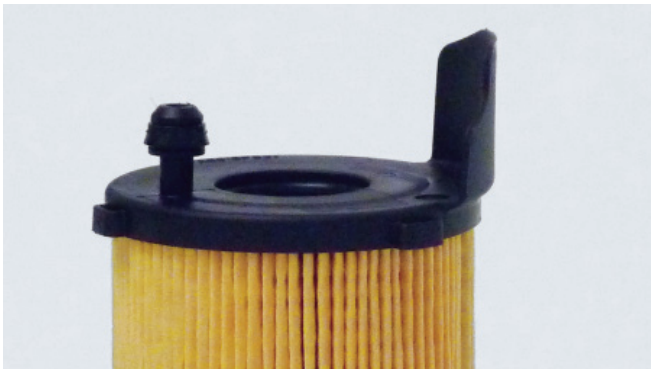
Figure 3: Replica with blade: while it may not damage MAHLE's patent, it can potentially damage the by-pass valve on the engine.

TREACHEROUS COPIIES WITH DESTRUCTIVE BLADES
In order not to violate MAHLE's patents, competitors have attached a large plastic blade to the end plate in their efforts to copy our filter insert.

This blade can turn into a destructive weapon: it can get caught when screwing the cover into the housing. In this case, the filter insert can no longer rotate. The fatal consequence: the pin can no longer slide along the helix, and the mechanic does not have a guide anymore to line up the pin exactly with the bore—an extremely difficult task.

Another problem: the sharp plastic blade can come dangerously close to the by-pass valve in the housing, damage it, and put it out of action. This means: the by-pass valve, which should only be opened for short periods in certain situations, is now permanently open—and lets the unfiltered oil circulate (unnoticed!) continuously through the engine. The inevitable consequence is serious engine damage!

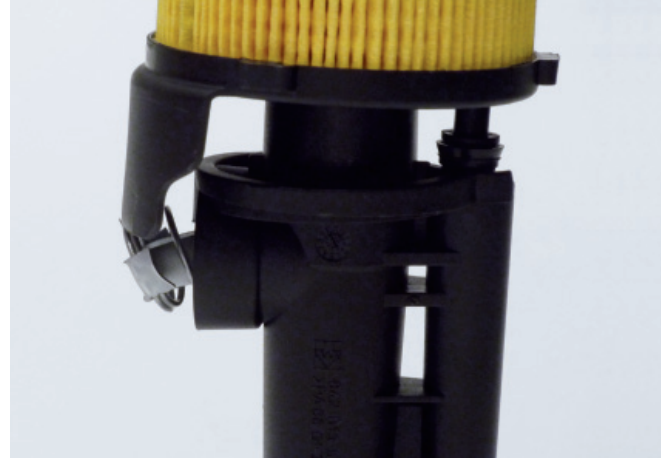
Figure 4: Detailed view of the damaged by-pass valve.
